PIPE LINING WITH CONCRETE

PNEUMATICALLY APPLIED CONCRETE

CULVERT PROGRAM

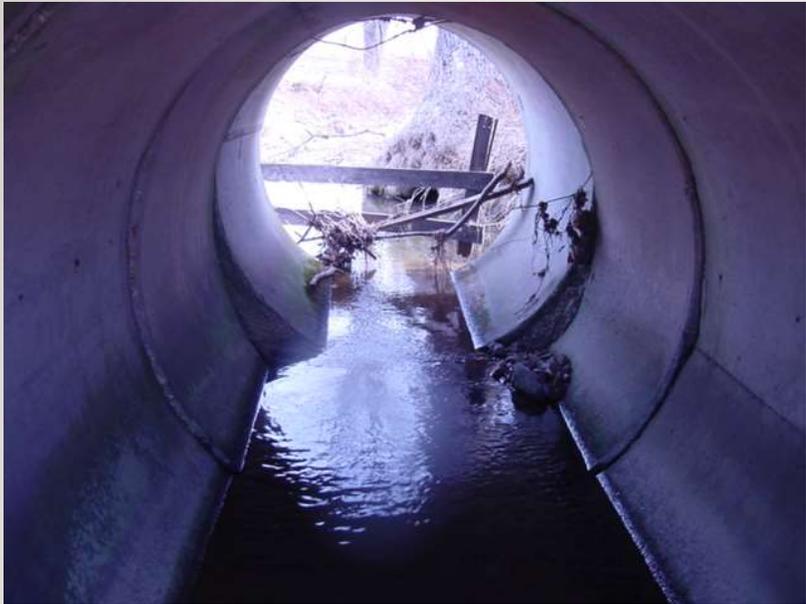
JOINT FAILURE

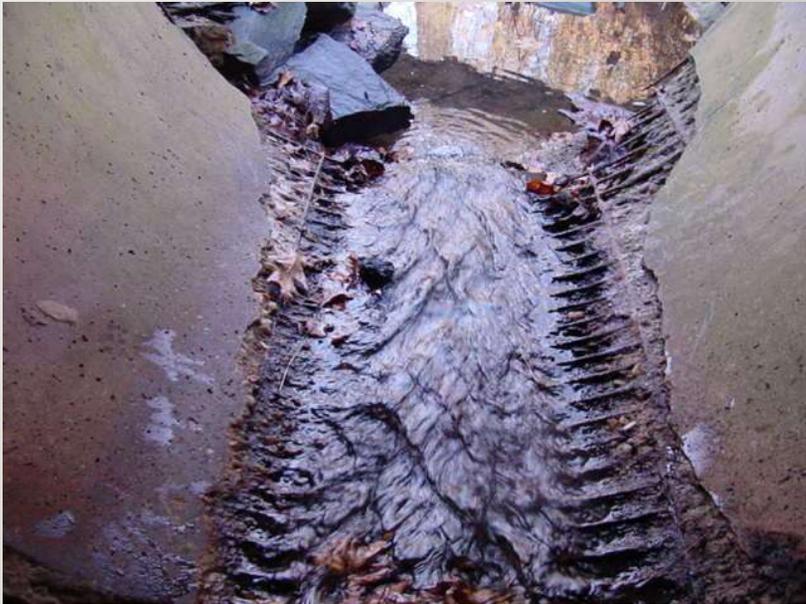
EXPOSED REINFORCEMENT

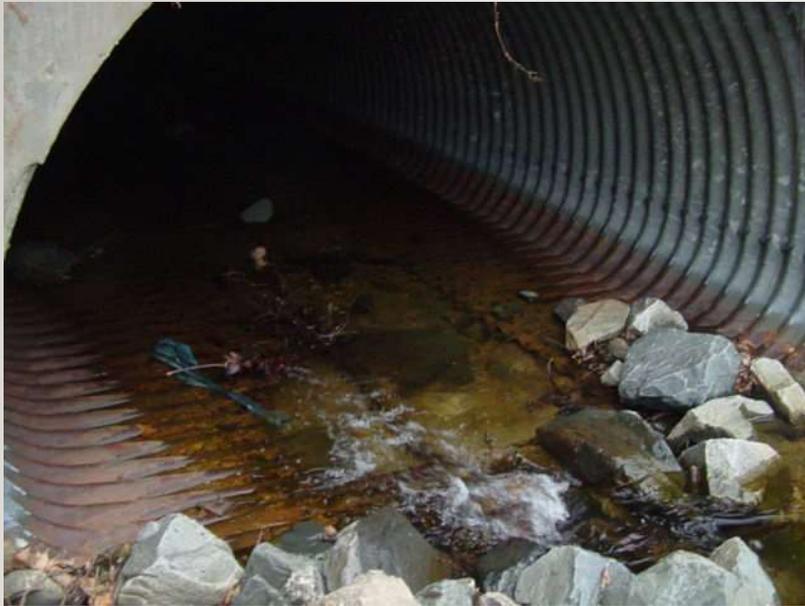
RUSTING AT INVERT

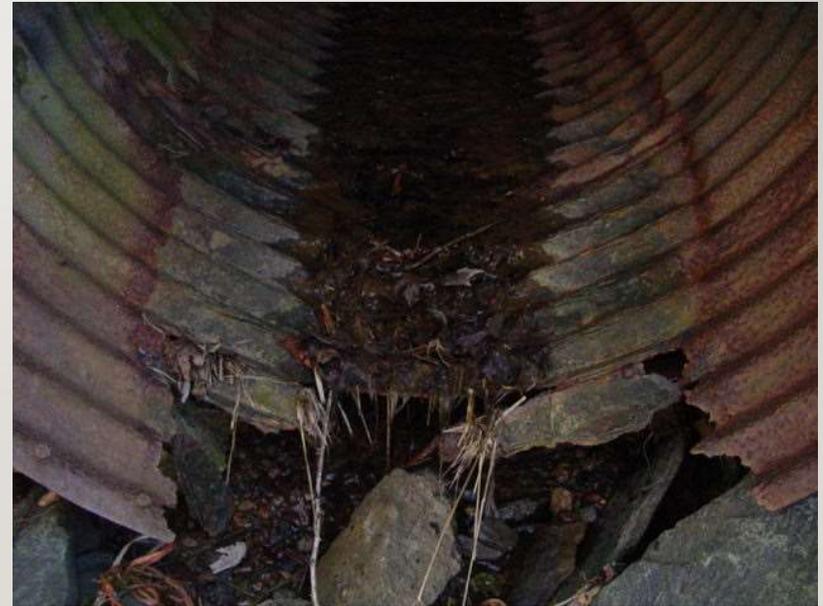
INVERT FAILURE

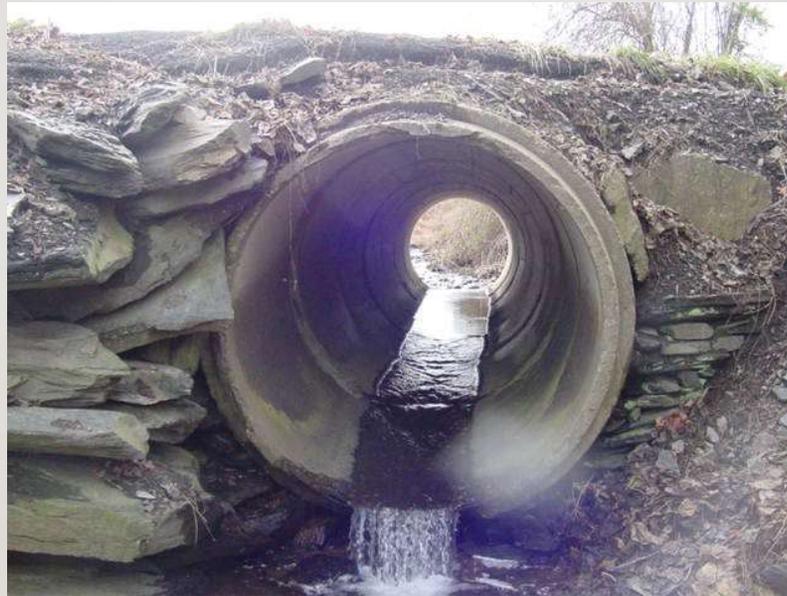
JOHNSON MILL ROAD BEFORE THE FACT

- CONCRETE PIPE WITH JOINT SEPARATIONS
- EXPOSED REINFORCEMENT THROUGHOUT PIPE
- FAILING STONE ENDWALL

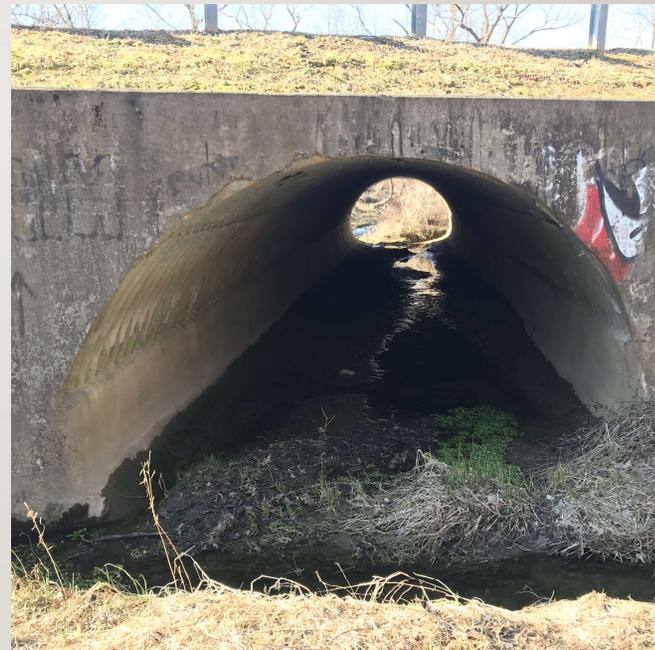
2019

- ONCE REPAIRED, WE ORIGINALLY ANTICIPATED AN ADDITIONAL 20 TO 25 YEARS OF LIFE TO THE EXISTING STRUCTURE
- WE DEVELOPED A REPAIR PROGRAM USING PNEUMATICALLY APPLIED CONCRETE AND DEVELOPED OUR OWN ON-CALL CONTRACT
- THE REPAIRS WE DID 15 YEARS AGO ARE STILL HOLDING UP WELL

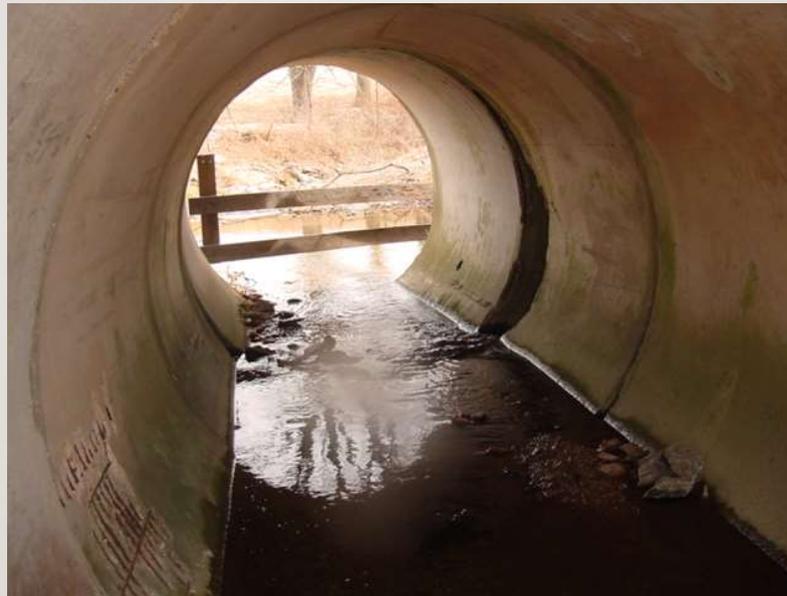
THIS IS HOW CONCRETE PIPE CULVERT FAILS THROUGH JOINTS

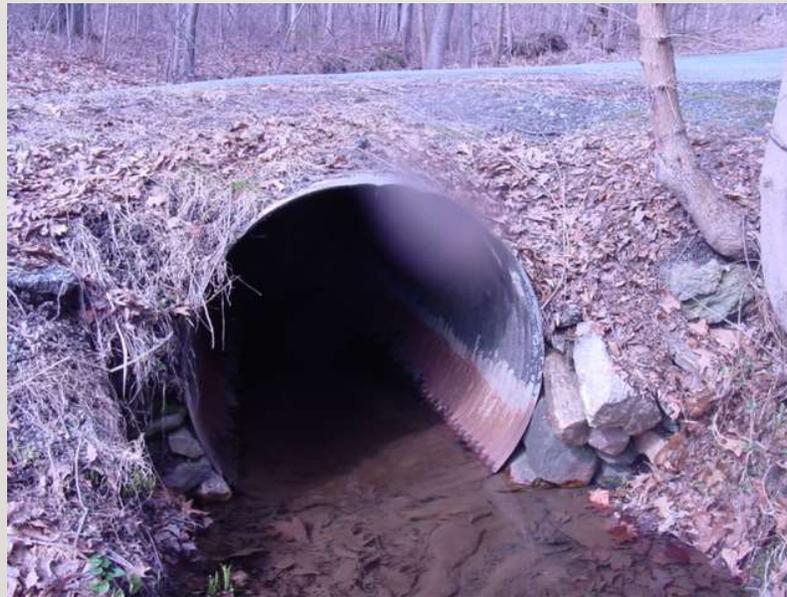
THIS IS HOW METAL PIPE CULVERT INVERT FAIL

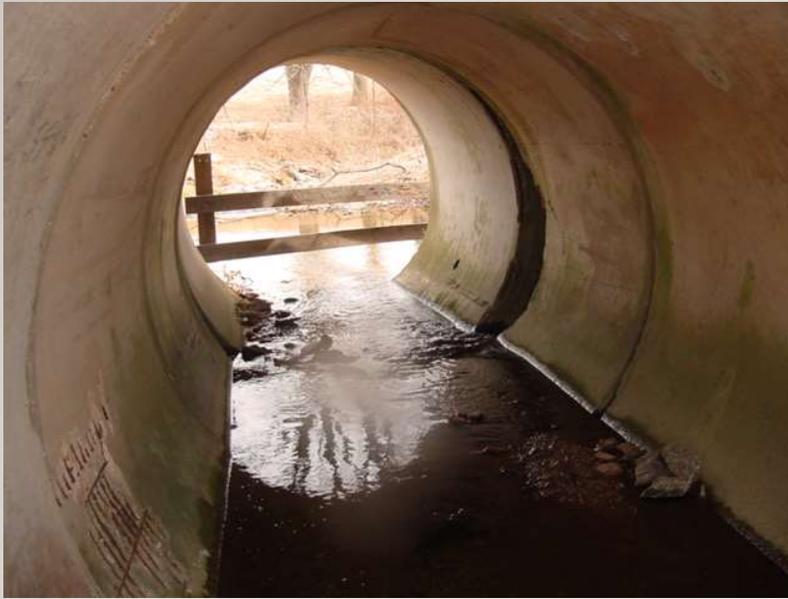
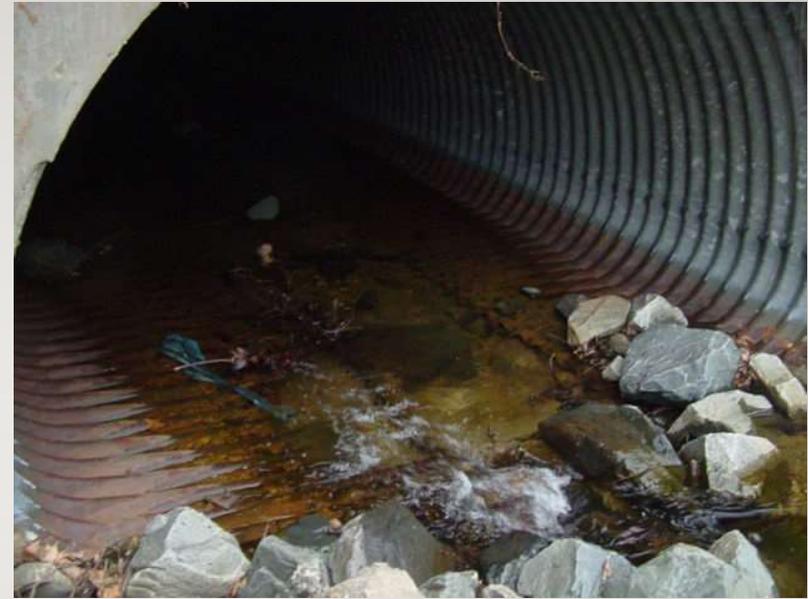
CONCRETE PIPES USUALLY FAIL AT THE JOINTS WHILE METAL PIPES FAIL AT INVERT AS IT RUSTS WHERE WATER IN CONSTANT CONTACT WITH THE METAL.
