PIPE LINING WITH CONCRETE

PNEUMATICALLY APPLIED CONCRETE

CULVERT PROGRAM

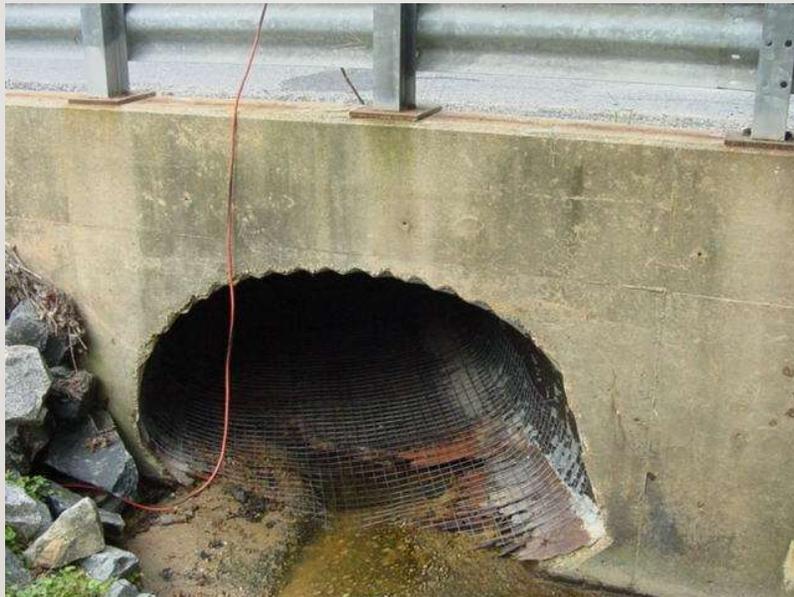
WIRE MESH BEFORE APPLYING THE PNEUMATICALLY APPLIED CONCRETE

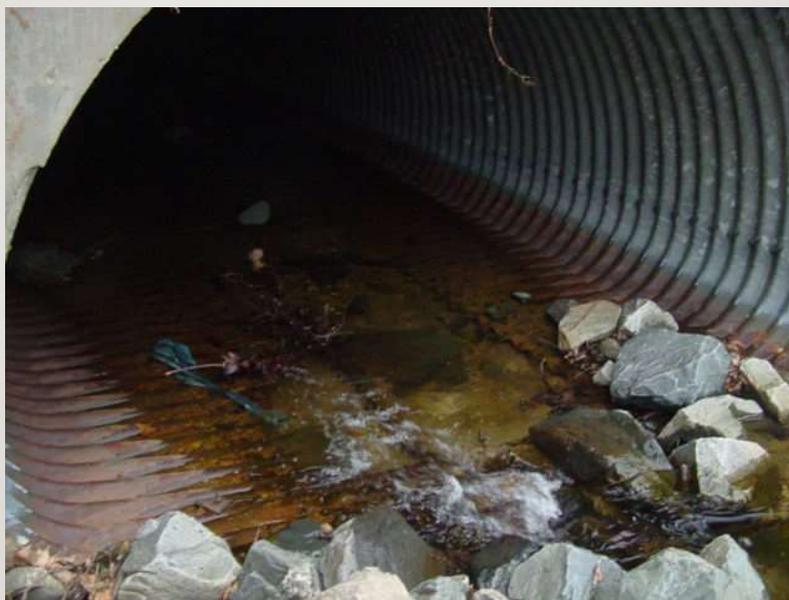
THIS IS HOW CONCRETE PIPE CULVERT FAILS THROUGH JOINTS

CONCRETE PIPES USUALLY FAIL AT THE JOINTS WHILE METAL PIPES FAIL AT INVERT AS IT RUSTS WHERE WATER IN CONSTANT CONTACT WITH THE METAL.
